**Flood Control Project Maintenance
Levee Inspections**

Spring 2010 Levee Inspection Results

Yolo County Service Area 6

Waterway			Bank	Unit Miles
Unit No. 01 Right Bank of Sacramento River at Knights Landing			Right	5.97
	Spring (March - May)	Summer (June - August)	(September - November) Fall	Winter (December - February)
Unit Maintenance Rating (Fall Only)				
Date of Inspection	4/5/2010 - 5/5/2010			
DWR Inspector	John Williamson			
Accompanied By

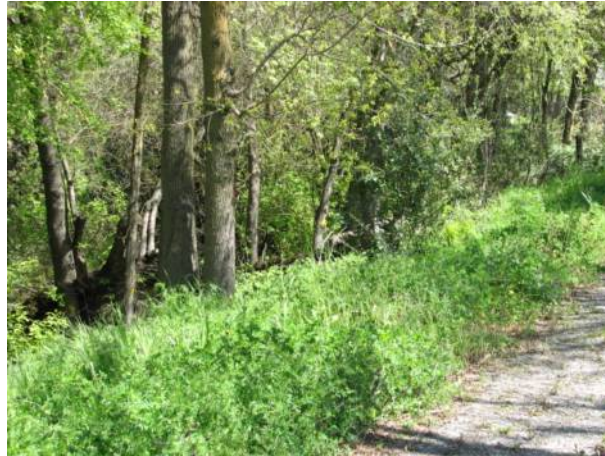
Levee Mile Report Line	5
Start Levee Mile	0.12
End Levee Mile	0.20
Location	Water Side
Category	Earthen Levee
Item	Vegetation
remove all brush except grasses	
johngw_s_20100405_105.jpg

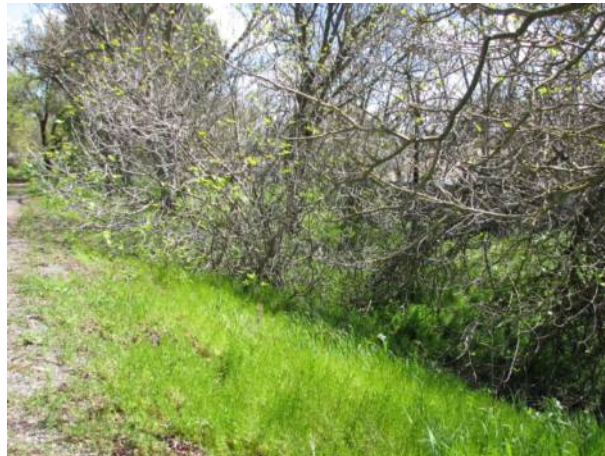
Levee Mile Report Line	6
Start Levee Mile	0.15
End Levee Mile	0.15
Location	Land Side
Category	Earthen Levee
Item	Trim / Thin Trees
fig tree on landside other trees need to be trimmed	
johngw_s_20100405_104.jpg

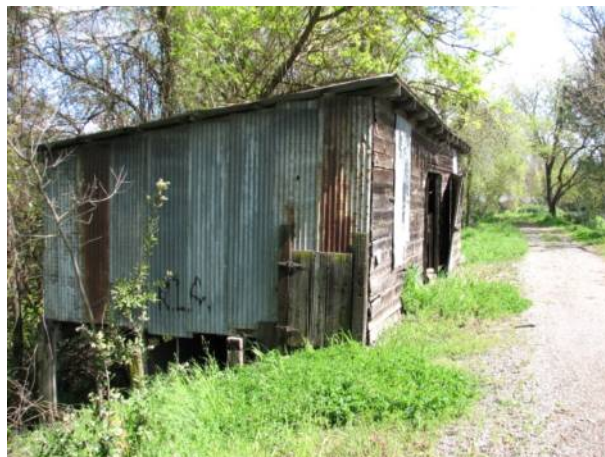
Levee Mile Report Line	7
Start Levee Mile	0.15
End Levee Mile	0.15
Location	Water Side
Category	Earthen Levee
Item	Encroachments
building on waterside	
johngw_s_20100405_103.jpg

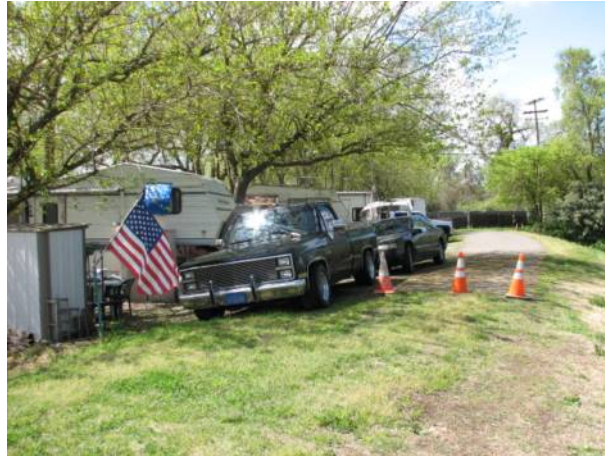
Levee Mile Report Line	8
Start Levee Mile	0.22
End Levee Mile	0.26
Location	Land Side
Category	Earthen Levee
Item	Encroachments
RV park trailers and vehicles on levee	
johnngw_s_20100405_107.jpg

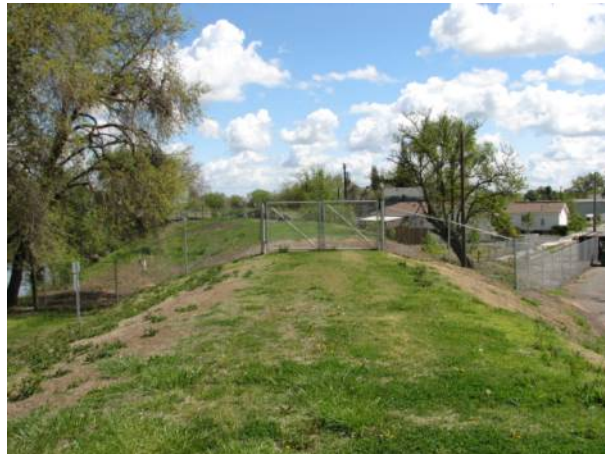
Levee Mile Report Line	9
Start Levee Mile	0.31
End Levee Mile	0.33
Location	Land Side
Category	Earthen Levee
Item	Encroachments
Fence across levee	
johnngw_s_20100405_108.jpg

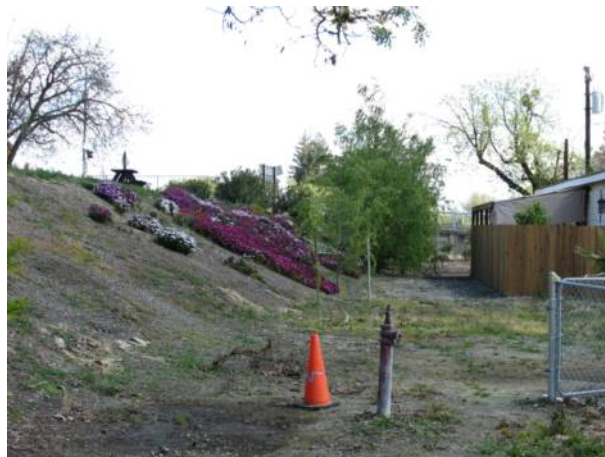
Levee Mile Report Line	9
Start Levee Mile	0.31
End Levee Mile	0.33
Location	Land Side
Category	Earthen Levee
Item	Encroachments
landscape on levee slope	
johnngw_s_20100405_109.jpg

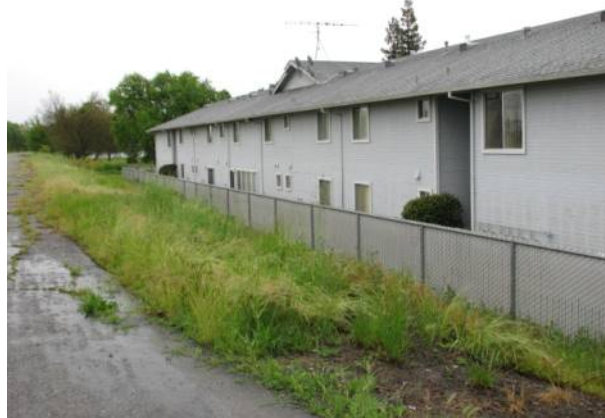
Levee Mile Report Line	10
Start Levee Mile	0.35
End Levee Mile	0.39
Location	Land Side
Category	Earthen Levee
Item	Encroachments
apartments and fence	
johngw_s_20100518_181.jpg

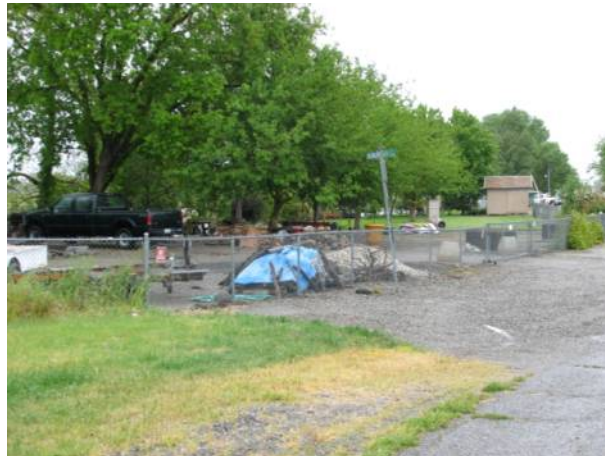
Levee Mile Report Line	11
Start Levee Mile	0.50
End Levee Mile	0.57
Location	Water Side
Category	Earthen Levee
Item	Encroachments
on levee crown	
johngw_s_20100518_182.jpg

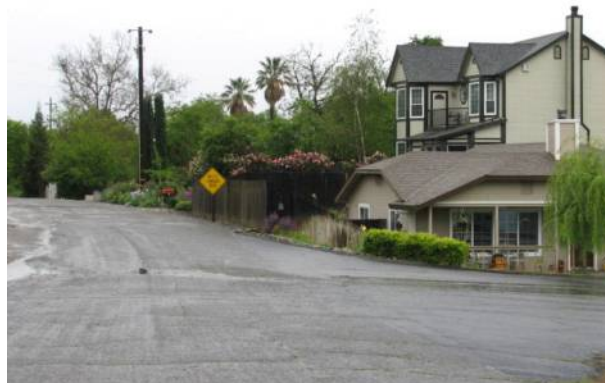
Levee Mile Report Line	12
Start Levee Mile	0.51
End Levee Mile	0.57
Location	Land Side
Category	Earthen Levee
Item	Encroachments
houses on levee	
johngw_s_20100518_183.jpg

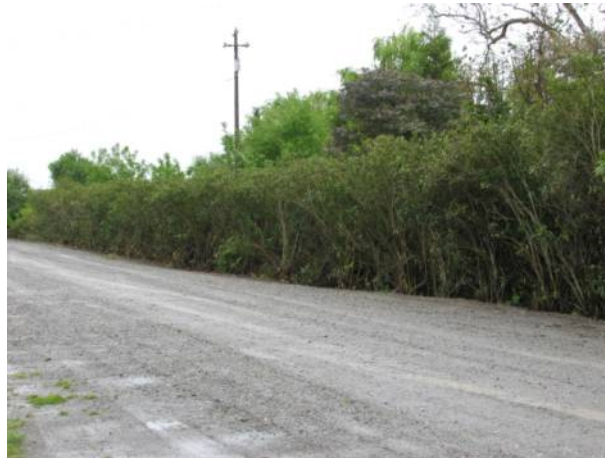
Levee Mile Report Line	13
Start Levee Mile	0.57
End Levee Mile	0.71
Location	Land Side
Category	Earthen Levee
Item	Encroachments

oleanders along shoulder

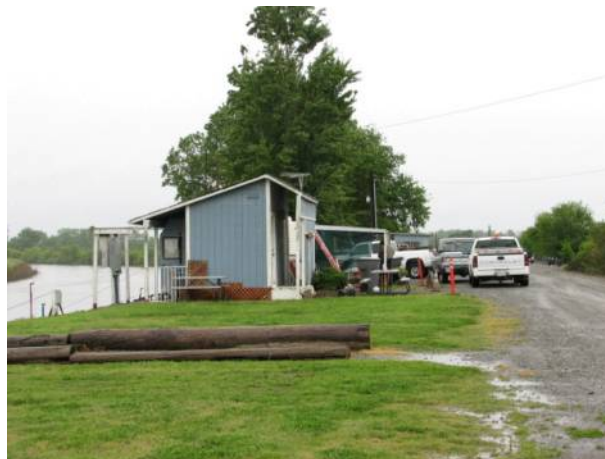
Levee Mile Report Line	14
Start Levee Mile	0.57
End Levee Mile	0.65
Location	Water Side
Category	Earthen Levee
Item	Encroachments

yacht club

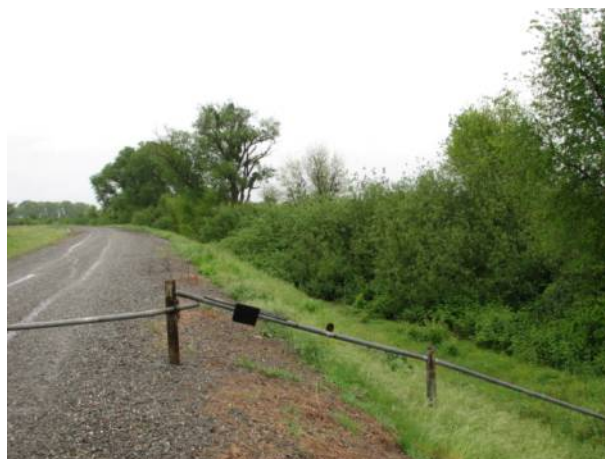
Levee Mile Report Line	19
Start Levee Mile	0.97
End Levee Mile	1.14
Location	Land Side
Category	Earthen Levee
Item	Vegetation

vegetation on landside

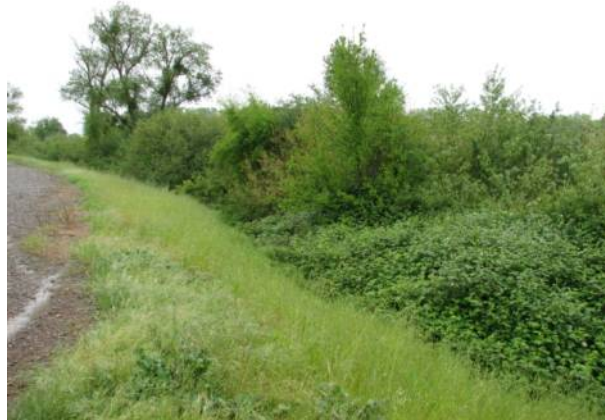
Levee Mile Report Line	20
Start Levee Mile	1.18
End Levee Mile	1.34
Location	Land Side
Category	Earthen Levee
Item	Vegetation
vegetation on landside	
johnngw_s_20100518_187.jpg

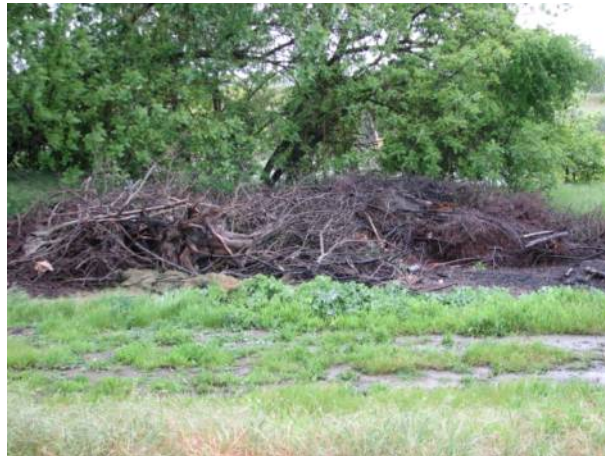
Levee Mile Report Line	21
Start Levee Mile	1.78
End Levee Mile	1.78
Location	Water Side
Category	Earthen Levee
Item	Encroachments
prunings	
johnngw_s_20100518_188.jpg

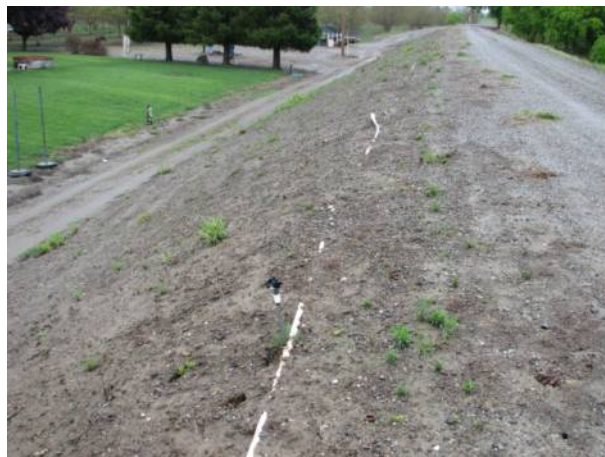
Levee Mile Report Line	22
Start Levee Mile	1.91
End Levee Mile	1.91
Location	Land Side
Category	Earthen Levee
Item	Encroachments
sprinklers and landscape	
johnngw_s_20100518_189.jpg

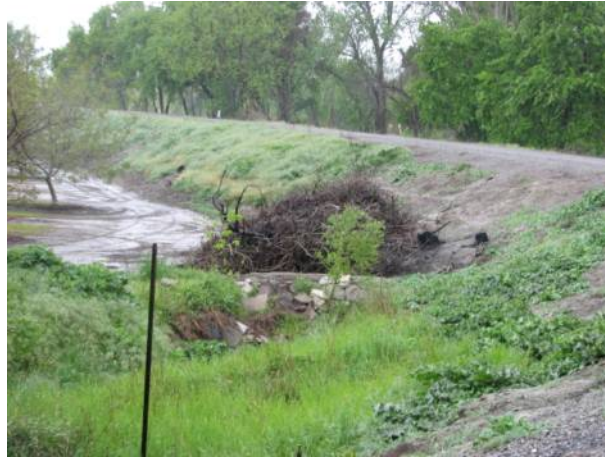
Levee Mile Report Line	23
Start Levee Mile	1.99
End Levee Mile	1.99
Location	Land Side
Category	Earthen Levee
Item	Encroachments

orchard prunings

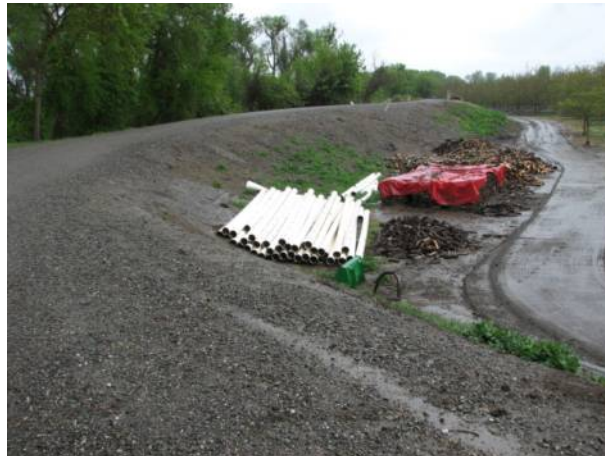
Levee Mile Report Line	25
Start Levee Mile	2.22
End Levee Mile	2.22
Location	Land Side
Category	Earthen Levee
Item	Encroachments

pipe along toe

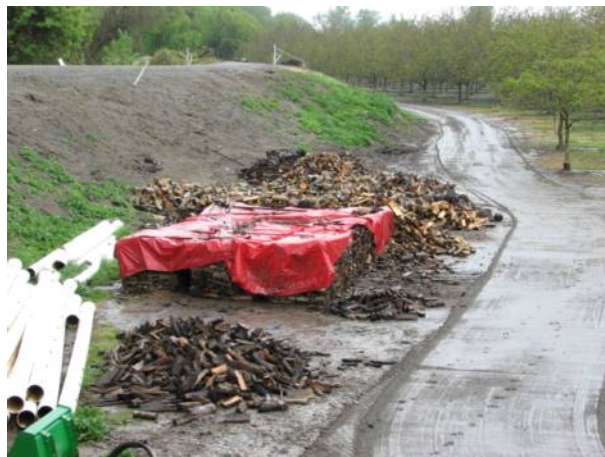
Levee Mile Report Line	26
Start Levee Mile	2.24
End Levee Mile	2.24
Location	Land Side
Category	Earthen Levee
Item	Encroachments

firewood stacked up

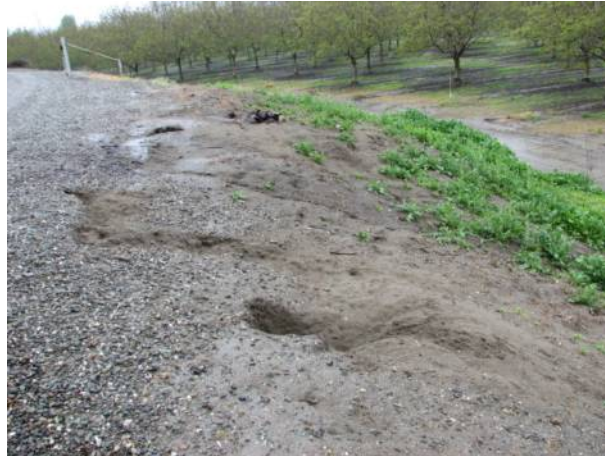
Levee Mile Report Line	27
Start Levee Mile	2.25
End Levee Mile	2.25
Location	Land Side
Category	Earthen Levee
Item	Animal Control

rodents

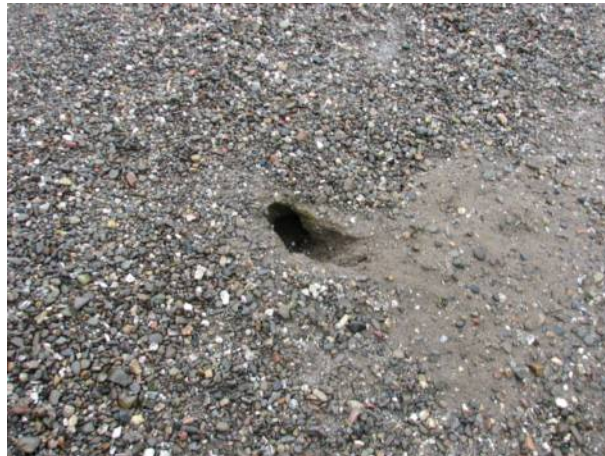
Levee Mile Report Line	27
Start Levee Mile	2.25
End Levee Mile	2.25
Location	Land Side
Category	Earthen Levee
Item	Animal Control

close up of hole

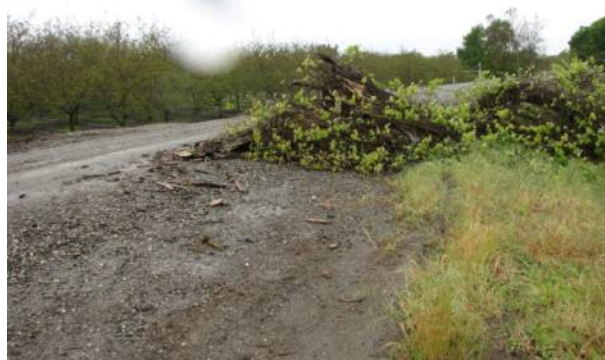
Levee Mile Report Line	28
Start Levee Mile	2.30
End Levee Mile	2.30
Location	Water Side
Category	Earthen Levee
Item	Trim / Thin Trees

28	2.30	2.30	Earthen Levee	Trim / Thin Trees	WS	U	Trim and thin trees to allow visibility of the ground and room to flood fight. Inspector Comments: tree fell across crown, but still accessible. Tree needs to cut up and remove or burned.	38.791321 ° -121.695261 °	38.791321 ° -121.695261 °	52 Y
29	2.62	2.62	Earthen Levee	Encroachments	LS	PO	Buildings	38.786964 ° -121.694239 °	38.786964 ° -121.694239 °	11 Y
30	2.97	2.97	Earthen Levee	Encroachments	LS	M	Prunings	38.782985 ° -121.691518 °	38.782985 ° -121.691518 °	13 Y
31	2.97	2.97	Earthen Levee	Animal Control	LS	M	Exterminate rodents and backfill and compact or grout burrows.	38.782985 ° -121.691518 °	38.782985 ° -121.691518 °	14
32	3.12	3.19	Earthen Levee	Encroachments	LS	PO	Buildings	38.781828 ° -121.689415 °	38.780852 ° -121.688887 °	12

tree across levee

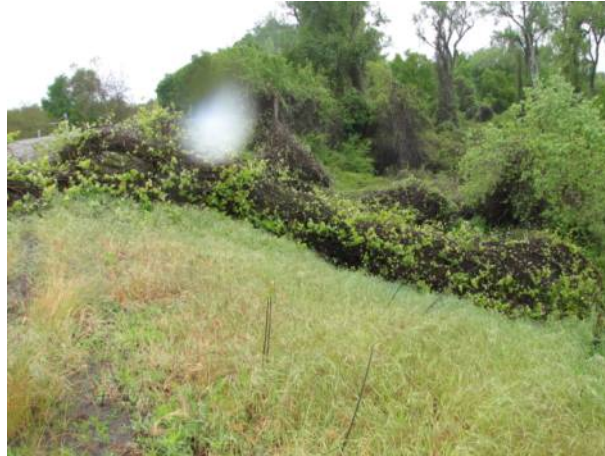
Levee Mile Report Line	28
Start Levee Mile	2.30
End Levee Mile	2.30
Location	Water Side
Category	Earthen Levee
Item	Trim / Thin Trees

water side view

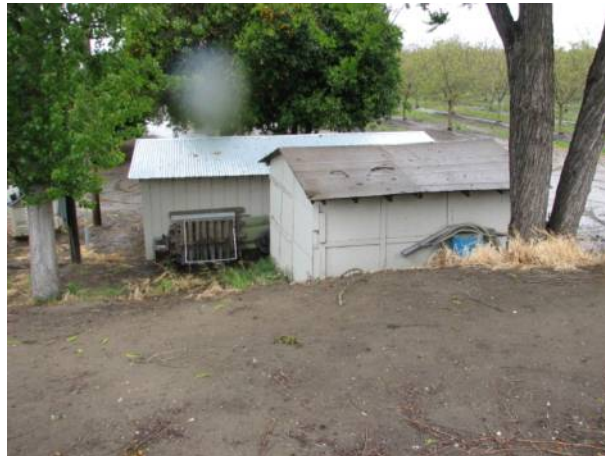
Levee Mile Report Line	29
Start Levee Mile	2.62
End Levee Mile	2.62
Location	Land Side
Category	Earthen Levee
Item	Encroachments

garage at toe

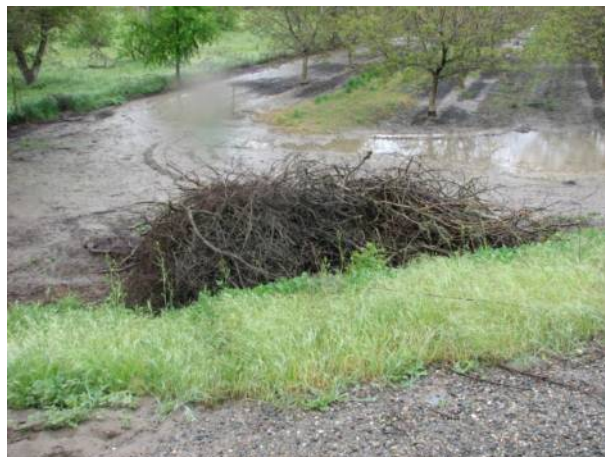
Levee Mile Report Line	30
Start Levee Mile	2.97
End Levee Mile	2.97
Location	Land Side
Category	Earthen Levee
Item	Encroachments

prunings

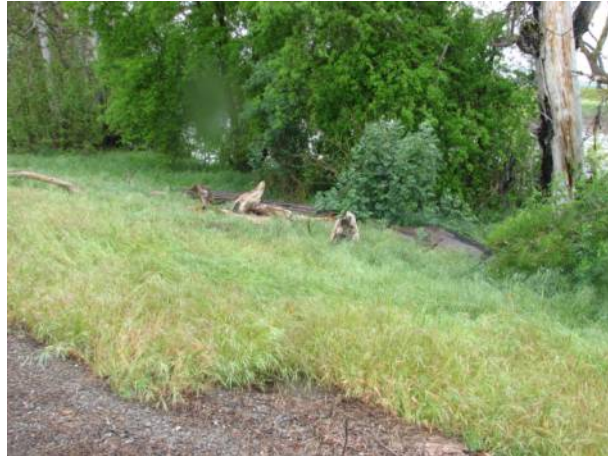
Levee Mile Report Line	34
Start Levee Mile	3.25
End Levee Mile	3.25
Location	Water Side
Category	Earthen Levee
Item	Trim / Thin Trees
branches from dead trees, water side	
johnngw_s_20100518_200.jpg

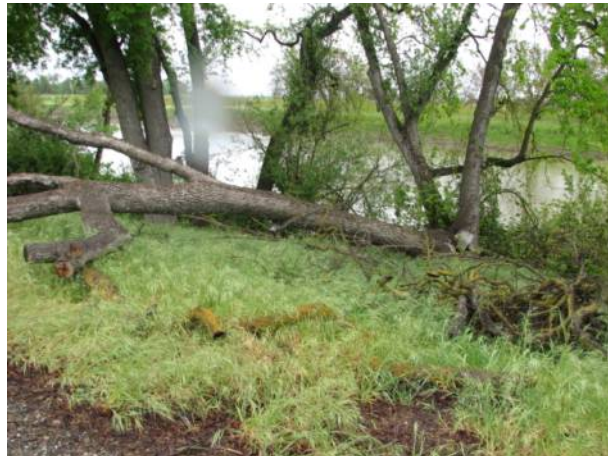
Levee Mile Report Line	35
Start Levee Mile	3.33
End Levee Mile	3.33
Location	Water Side
Category	Earthen Levee
Item	Trim / Thin Trees
winter storm damage	
johnngw_s_20100518_201.jpg

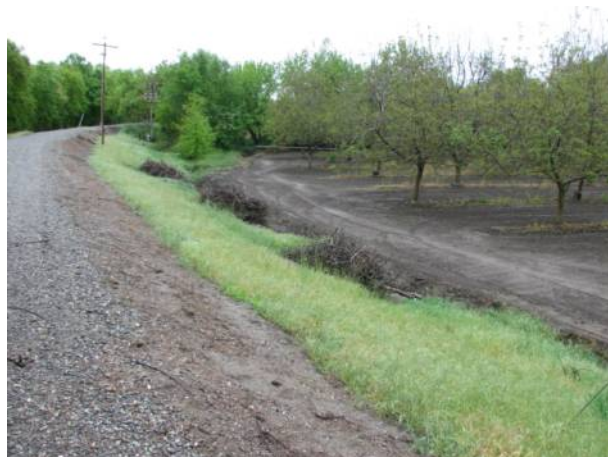
Levee Mile Report Line	37
Start Levee Mile	3.40
End Levee Mile	3.40
Location	Land Side
Category	Earthen Levee
Item	Encroachments
several piles of prunings	
johnngw_s_20100518_199.jpg

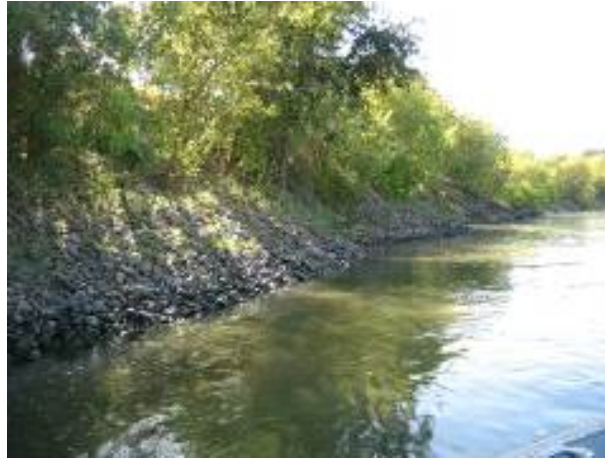
38	4.74	4.95	Supplemental	USACE Erosion Survey	WS	U	Inspector Comments: 2009: 5 ft berm, 1.5:1 slope, slumping, silts, 3.21 ft/s [2009 SiteID:SAC_85-4_R]	38.763314 ° -121.684039 °	38.763486 ° -121.687567 °	33 Y
39	5.60	5.65	Earthen Levee	Encroachments	LS	PO	Buildings	38.759620 ° -121.673903 °	38.759412 ° -121.673167 °	1

Levee Mile Report Line	38
Start Levee Mile	4.74
End Levee Mile	4.95
Location	Water Side
Category	Supplemental
Item	USACE Erosion Survey
2009: 5 ft berm, 1.5:1 slope, slumping, silts, 3.21 ft/s [2009 SiteID:SAC_85-4_R]	
USACE2009_SAC_85-4_R_2009_09_16-D2P54_small.JPG
